# Gate Valve Repair

## Repair #1 Replacing the O-rings

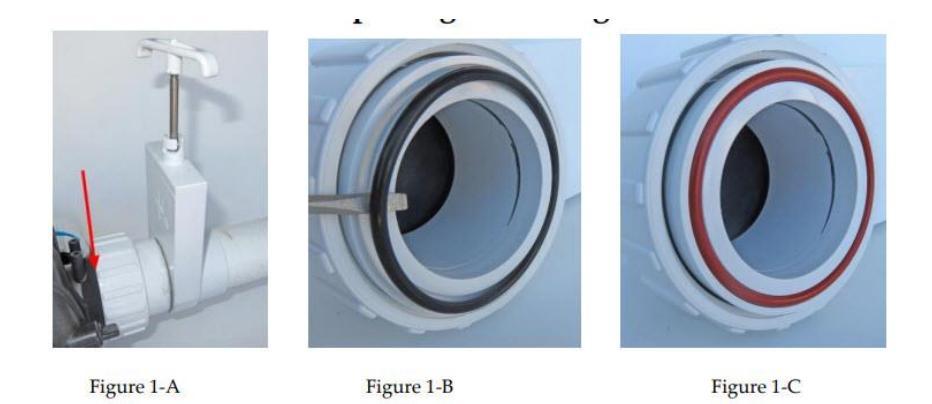
If a leak occurs where the collar attaches to the pump, (Figure 1-A), the O-ring may be the culprit. The O-ring can flatten over time causing leaks. You will need to remove the original O-ring and replace it with a new one. To remove the old O-ring, (Figure 1-B), insert the tip of a small flathead screwdriver between the O-ring and the plastic collar and pop it out of its seat. Insert a new O-ring (part number 01510-371) in its place. (Figure 1-C) We recommend replacing the O-ring on both Gate Valves at this time.

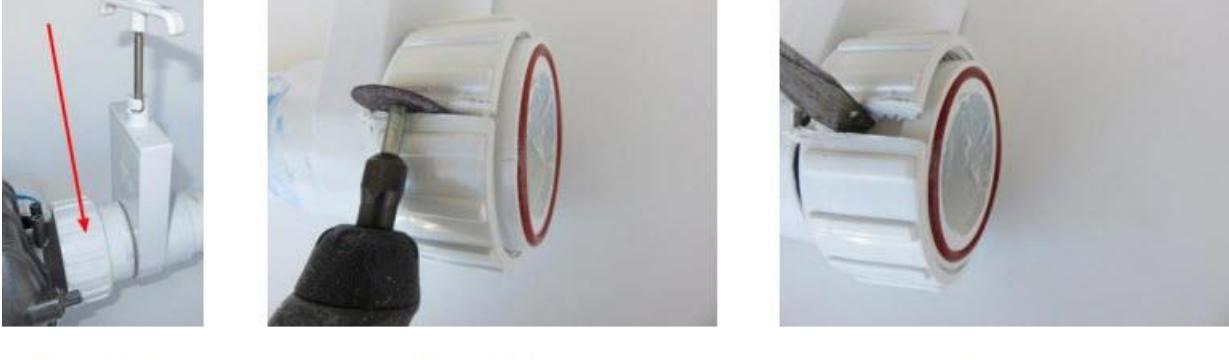
Figure 2-B

If the collar itself breaks, (Figure 2-A), you'll need a Split Nut – (part number 01510-184), to replace it. Using a Dremel, or an oscillating tool, (Figure 2-B), cut the collar as shown.

A hacksaw blade will also work but takes more time and patience. As you are cutting, be careful not to damage the threads on fitting below the damaged collar. Wedge a large flathead screwdriver into the cut and twist, (Figure 2-C), so the collar opens enough for easy removal. If this proves difficult, make a second cut on the opposite side of the first. This should make the collar easier to remove.

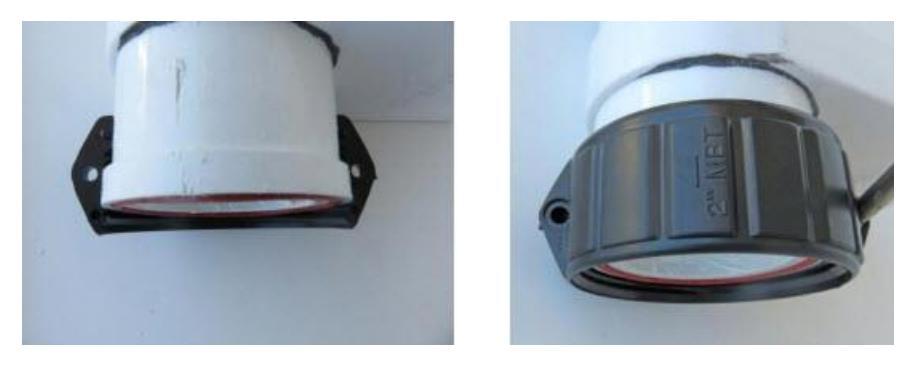
Figure 2-D

To install the new Split Nut, place one half under the fitting, (Figure 2-D). Lay the mating half of the union on top and line up the holes. Insert a screw into the recessed portion of the fitting and tighten halfway; (Figure 2-E). Thread the second screw almost all the way, then go back to the first screw and finish tightening it. Be sure everything is still aligned. Return to the second screw and tighten it completely. Install a new O-ring and reinstall the jet pump. All done!

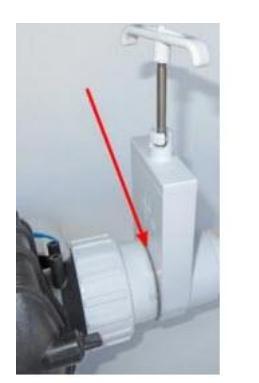
Figure 3-A

If a leak appears at the base of the valve (Figure 3-A), you'll need to seal the appropriate joints inside and outside the gate valve. Look about ¼" into the front of the valve assembly to locate the leaky joint (Figure 3-B).

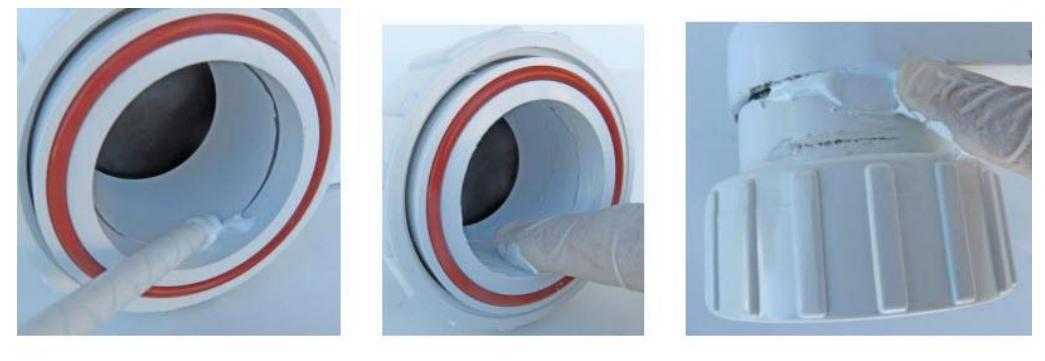
Figure 3-C

Put on the rubber gloves and using the Plastic Welder Repair Kit, apply a bead of epoxy over the seam, (Figure 3-C). Spread it evenly with your forefinger, or a popsicle stick. Be sure to cover the entire seam but keep the O-ring and collar clean. (Figure 3-D). You don't want to get the Plastic Welder on these two components, so please, work carefully.

Now, apply a bead of epoxy around the joint shown in Figure 3-E and spread it evenly with your finger. Don't get any epoxy on the back end of the collar or you won't be able to turn it. Once the epoxy has cured, (about 1 hour), reattach the pump and you are done.

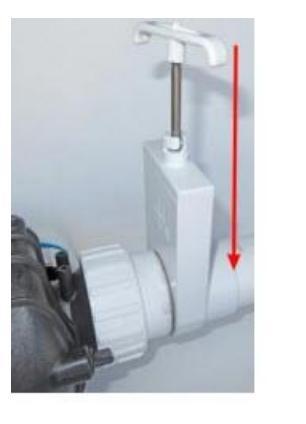
Figure 4-A

If you have a leaky front glue joint and are going to seal it, you may as well go ahead and do the rear one, too. This is where the back hose and gate valve are glued together, (Figure 4-A). You'll find the rear joint 2 ¾" from the front of the valve assembly. Be sure to keep the epoxy out of the gate seat or you won't be able to open and close the gate valve in the future. With your rubber gloves on, apply a bead of Plastic Welder over the seam and spread it evenly over the entire joint with your finger or a mixing stick. (Figure 4-B). It's easy to get a little epoxy in places it does not belong, so have a rag ready to wipe it off quickly, (it begins to set up in less than a minute). Once the epoxy is dry, you're done.

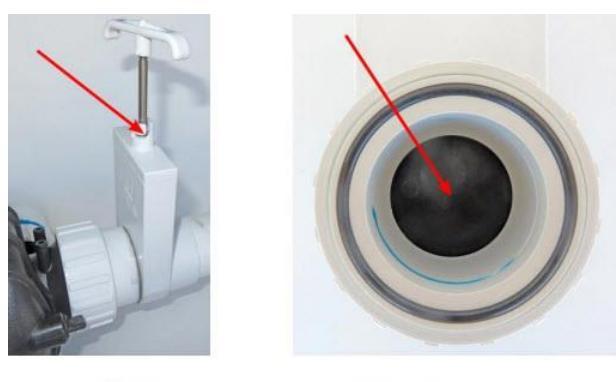
Figure 5-A

This one's a little different than the other repairs. If your gate valve is leaking at the top of the assembly where the metal stem enters the valve assembly, (Figure 5-A), you'll have to drill out the center rubber gate. Push the valve handle all the way down so the gate is fully seated, (Figure 5-B).

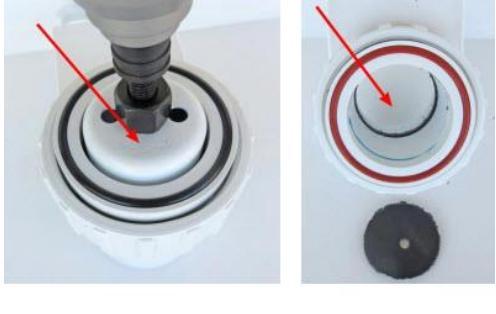
Figure 5-C

Look into the valve and using a 2" hole saw, (Figure 5-C), cut out the center of the gate. Remove the plug and shavings, leaving a hole, (Figure 5-D). Leave the handle in the closed position too. The hole will allow water to flow through the gate valve, while the remaining portion of the gate prevents leaking from the top.

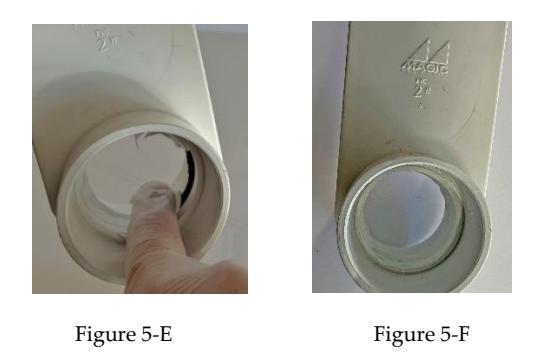
As a final precaution, apply epoxy around the circle where the remnants of the black gate remains. (Figure 5E). This will prevent any water from working its way up and through the handle stem. Wait 5 minutes and add a second layer for good measure. (Figure 5-F)
