Immediately Purge Your Circulation Pump Air Lock To Avoid Damaging The Motor

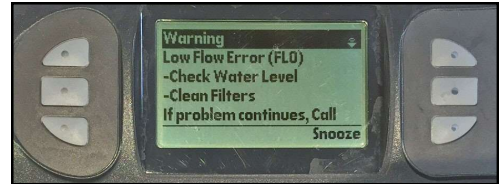
Without bubbles shooting out from the foot well, there will also be a “flow error” message on the upper control panel and the heater will not turn on.

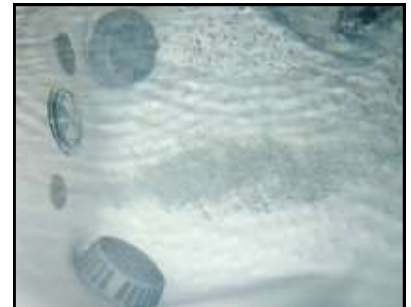
Step 1:

Air bubbles should be shooting out of the ozone/heater port in the foot well, about 18 inches. If not...

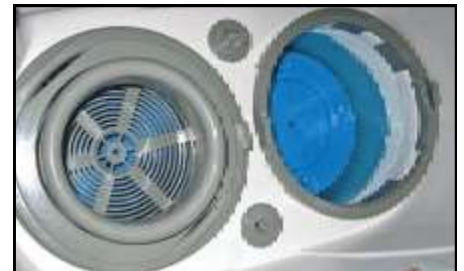
Step 2: Remove the air bleeder valves near the filters. There should be a constant stream of bubbles from the ozone bleeder valve port. If not...

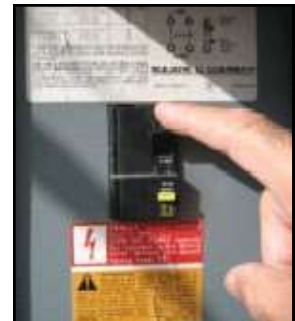
Step 3: Turn off power at the GFCI.

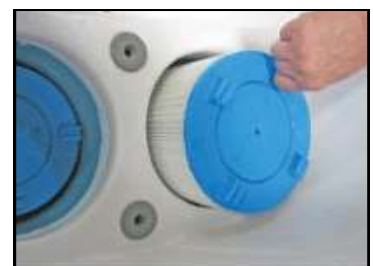
Step 4: Remove the ozone filter from its canister.

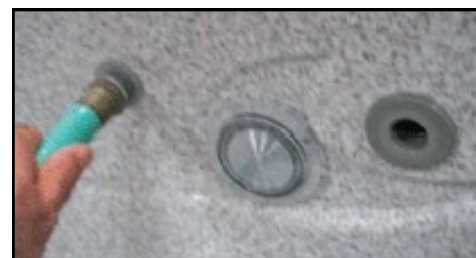
Step 8: Hold the running hose over the ozone port in the foot well and watch for bubbles to come through the port by the filter. You may have to repeat this top and bottom routine up to 3 times to purge all the air from the circulation pump plumbing.

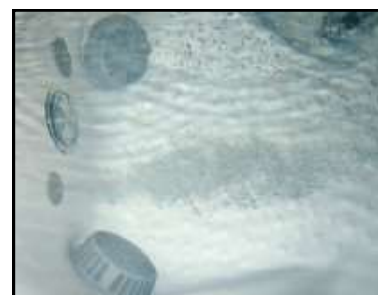
Step 9: Turn on power at the GFCI to see if the error message is gone and the bubbles are flowing again.

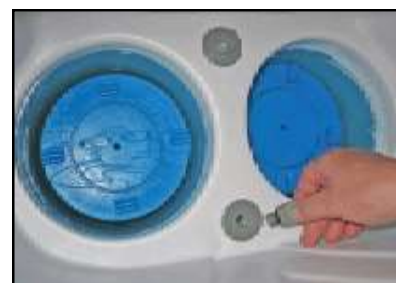
Step 10: When the circulation pump is operating normally, replace the bleeder valves, filters, and filter covers.
